Stormwater Assessment Study

Marvin Loop Trail

AMT Project Number 15-0072.003

June 2024

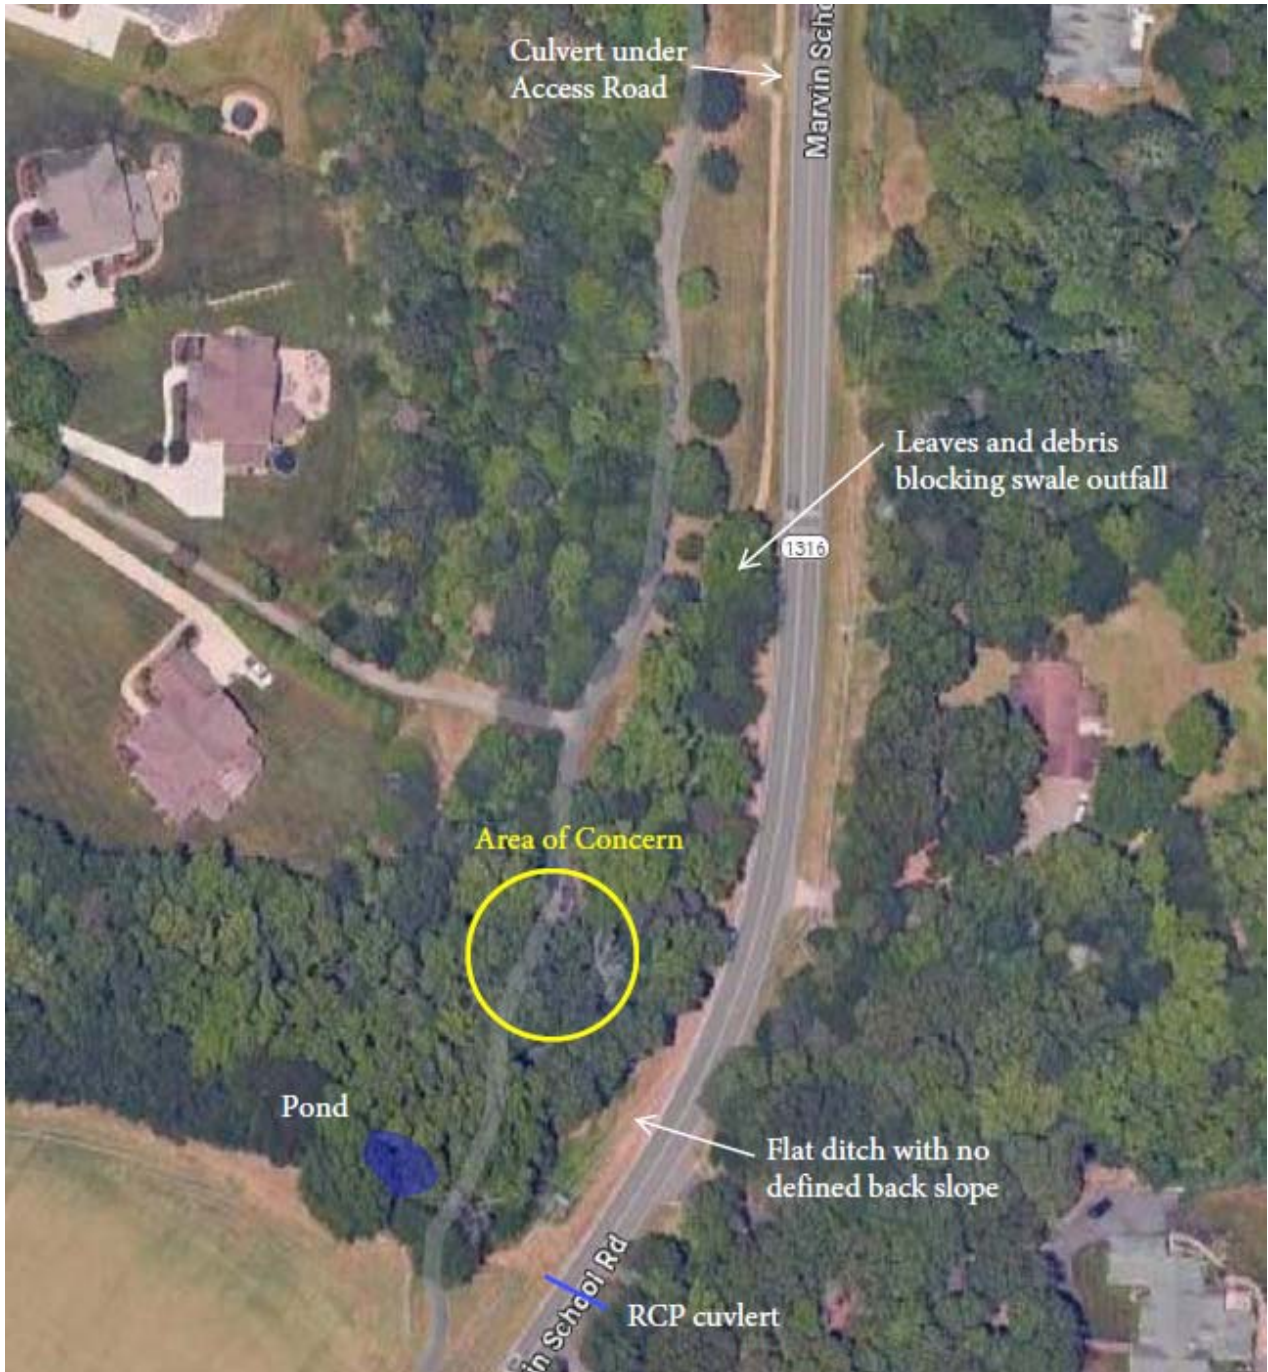
Figure 2: Site 1 – Existing Conditions
Source: Google Maps - Not to scale

Site 1 is located just north of the Marvin Elementary School where the trail enters into a wooded area. Based on Google Earth photos, it appears this section of the trail was constructed in 2008. Along the school property, a roadside ditch conveys runoff from the trail and roadway to the north. The ditch becomes less defined at the outfall of a culvert located under Marvin School Road that appears to flow to the west, towards the trail.

The culvert conveys approximately 4.60 acres of woods, residential homes, and a portion of roadway from the east side of Marvin School Road. During the site investigation, the culvert did not appear to be actively in use with vegetation and cobwebs lining the inflow and outlet. Any flow from the culvert appears to flow into the wooded area between the trail and the roadway. A roadside ditch begins near the edge of the woods but is very flat with an ill-defined backslope allowing for any runoff to flow into the woods.

As the trail enters the woods, there is a pond area to the left which does not appear to have a defined inflow or outflow points. It is not clear what the intent of this area was, it may have been constructed when the berm for the school was installed, however based on the depth, it does not appear the ponded water would impact the trail. The berm does not have any impact on the drainage to the trail.

The asphalt of the trail is built up a few inches preventing runoff from the west from flowing over the trail and towards the road. Based on the build up of sediment and debris and moisture of the soil on the left side of the trail, it appears that water may pond and overtop the trail in larger storm events. On the east side of the trail, there appears to be a small ditch/flow path in the woods. This area is fairly flat so sediment and debris and wet soils were noted. The flow path appears to flow to the north towards the road and roadside ditch however a build up of leaves and other woody debris has accumulated along the wood line and is preventing runoff from leaving the woods in the ditch. Since this area is flat, the runoff that would be conveyed in the small ditch may be backing up and causing flooding conditions on the trail and adjacent areas.

Once the trail exits the wooded area heading north, a more defined roadside swale exists. However, the slope of the ditch is very flat and may not have adequate capacity to convey the flow from the wooded area. There is a culvert in the roadside ditch to allow for vehicular or maintenance equipment to access the trail. The ends of the culvert have been damaged and the culvert has a large

accumulation of sand and silt which reduces the capacity and functionality of the pipe. The grass swale downstream of the culvert is in good condition and due to a steeper slope, appears to have adequate capacity to convey the ditch flow. The area draining to the culvert is 8.71 acres of woods, residential area, grass, and impervious area (trail and road).

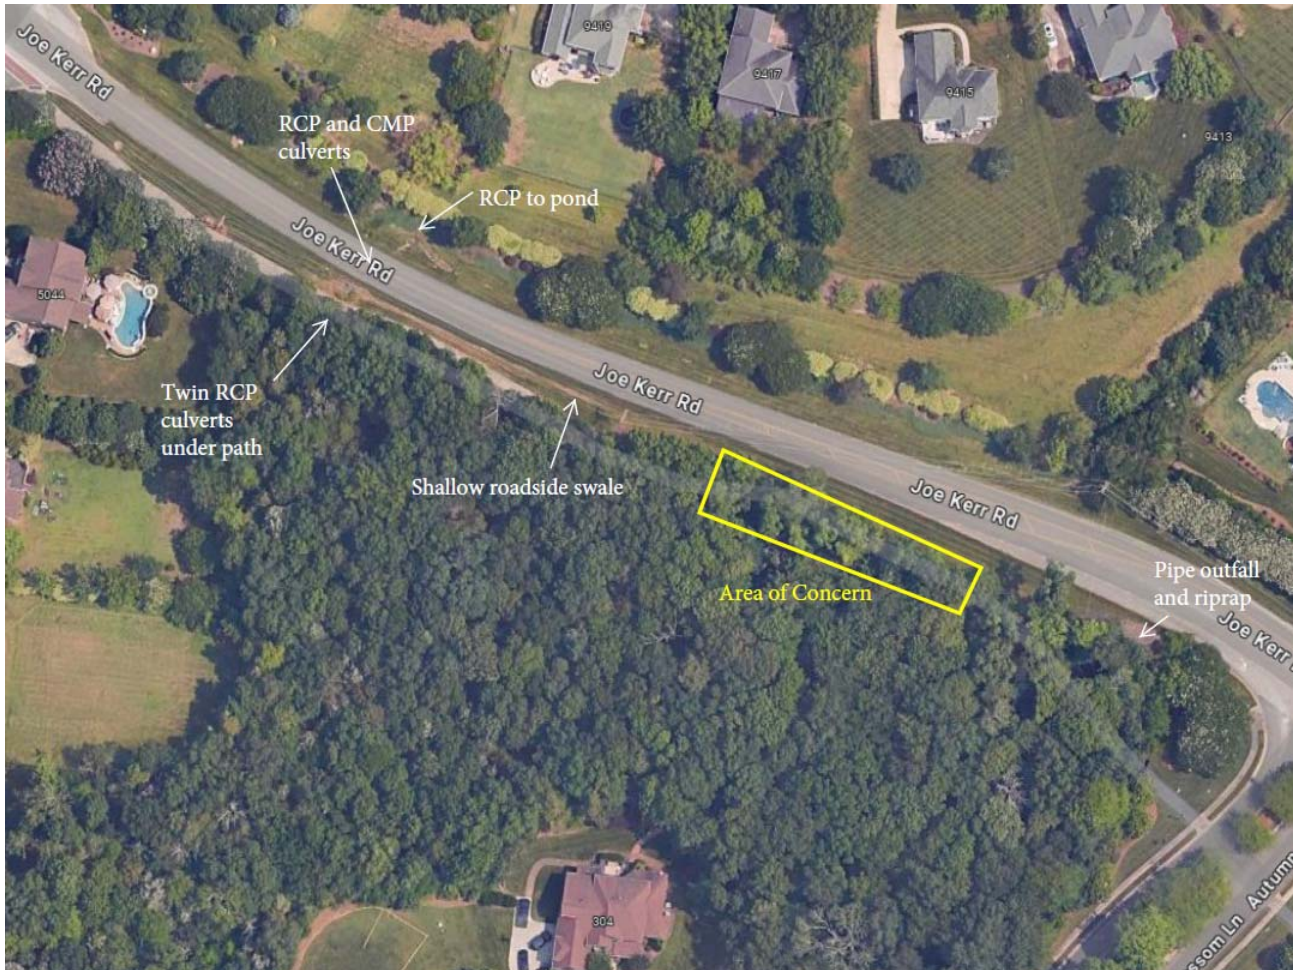
Figure 3: Site 2 – Existing Conditions
Source: Google Maps - Not to scale

Site 2 is located west of the intersection of Joe Kerr Road and Autumn Blossom Lane as the trail gets closer to Joe Kerr Road in the woods. Based on Google Earth photos, it appears this section of the trail was constructed between 2009 and 2010.

Similar to Site 1, the asphalt of the trail is built up a few inches preventing runoff from the south, particularly the properties along Hickory Bark Court, from flowing over the trail and towards the road. Based on the buildup of sediment, debris, and moisture of the soil on the left side of the trail, it appears that water may pond and overtop the trail in larger storm events. Runoff from Joe Kerr Road and two inlets along Autumn Blossom Lane outfall into a small riprap area approximately 100 feet west of Autumn Blossom Lane. The outfall pipe from the two inlets was mostly buried with sediment and riprap. Runoff downstream of the riprap appeared to flow into the woods between the trail and the road with no defined swale or roadside ditch. The area draining to the riprap area is approximately 4.29 acres of woods, residential area, and impervious (trail and roadway). As the trail gets closer to Joe Kerr Road and along the edge of the tree line, a small roadside ditch forms. However, this ditch does not have positive flow since standing water was observed. There is a gap in ditch between the riprap and the defined ditch section.

At the low point in the trail, twin RCP culverts convey runoff under the trail, into the ditch and towards a RCP and CMP culvert under Joe Kerr Road. The twin RCP culverts are partially filled with sediment. The headwall and endwall on either side of the trail are in good condition. The RCP culvert under Joe Kerr has disconnected at the first joint, is partially blocked with debris and has accumulated sediment in the invert,. The CMP culvert appears in ok condition with some accumulation of sediment and rocks. The outfall of the RCP culvert was mostly buried while there is erosion and a scour hole at the CMP outfall. The culvert outfalls in a ditch which ultimately flows into a RCP pipe that outfalls into a pond in the adjacent neighborhood. The area draining to the upstream end of the culverts under Joe Kerr Road is 9.68 acres of woods, residential area and impervious (trail and roadway).

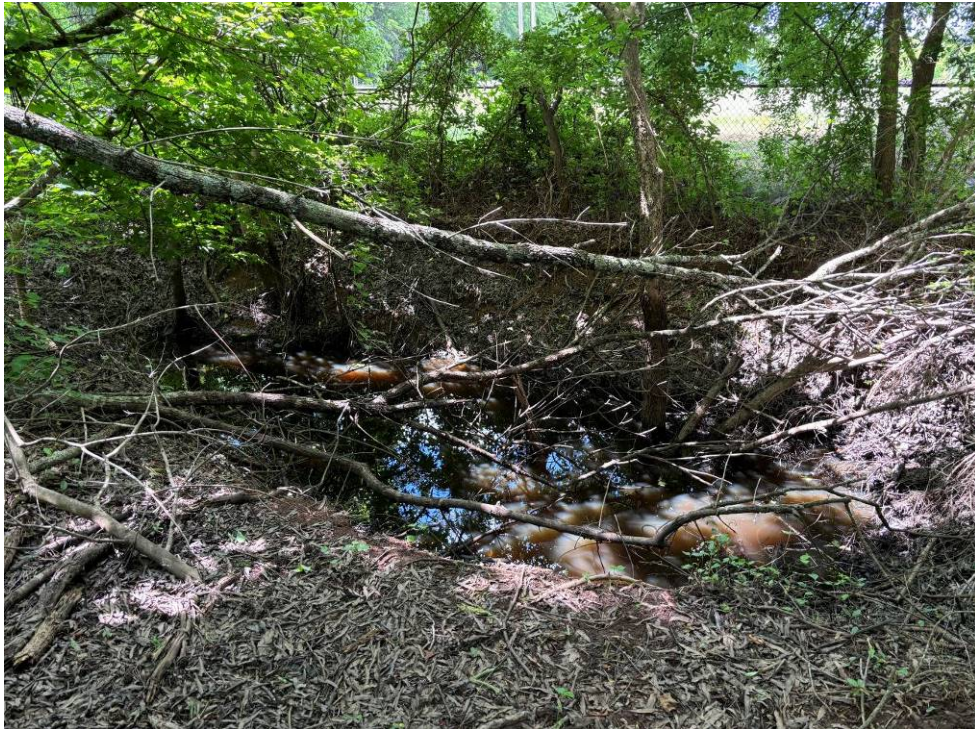
Photo 7: Deep ponded area of water on the west side of the trail. School fence is in the background.

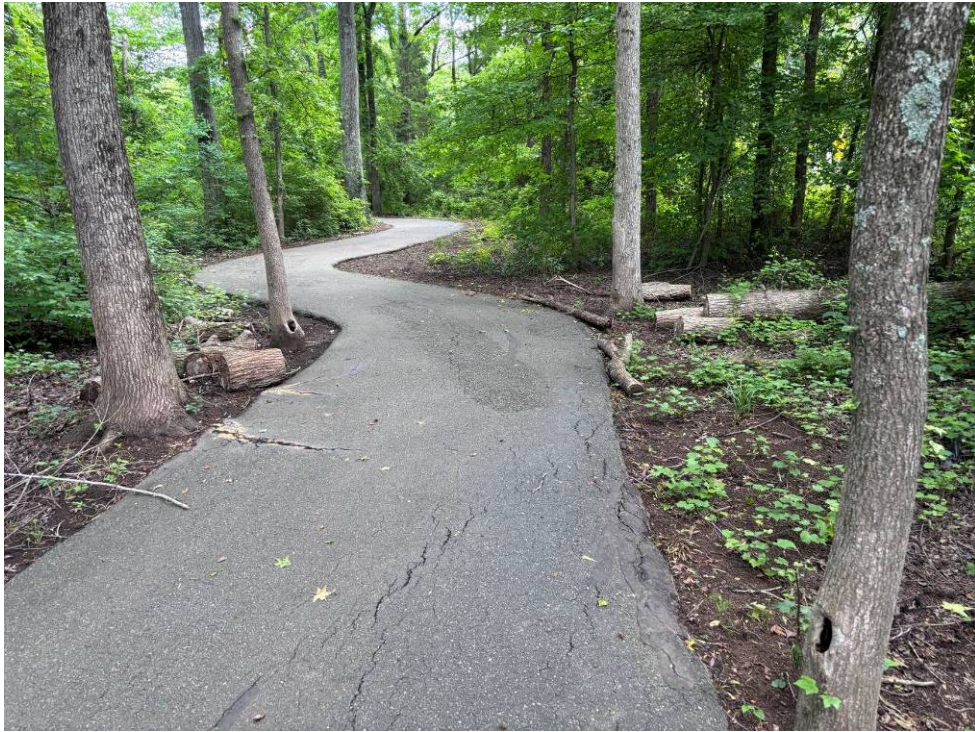
Photo 9: Northbound trail with areas of sediment build up and wet soil.

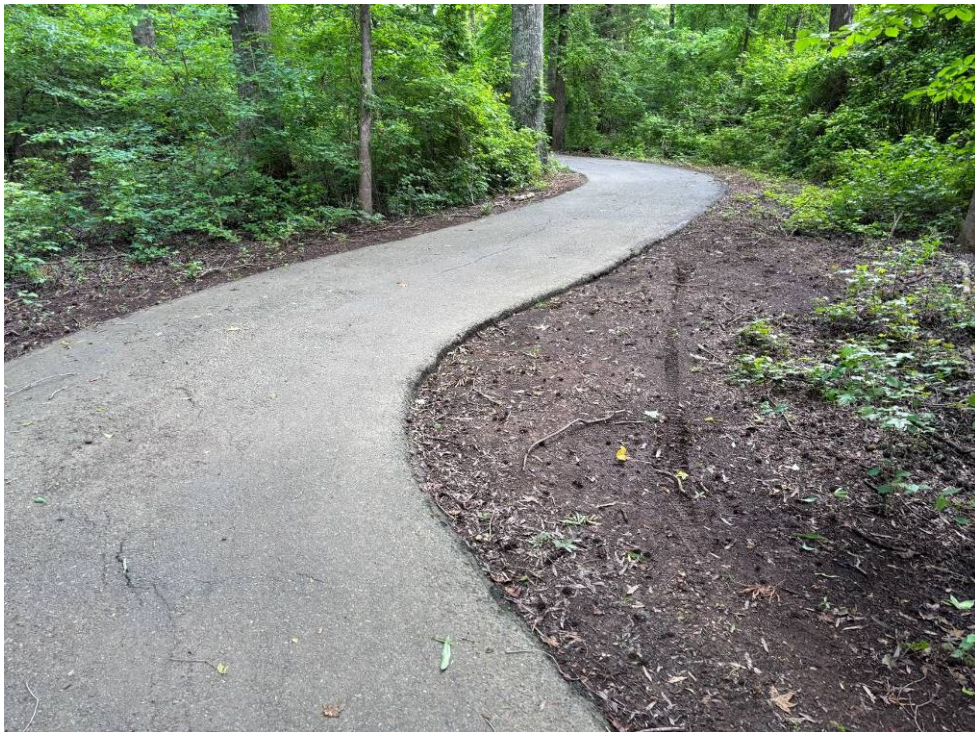
Photo 10: Northbound trail with areas of sediment build up and wet soil.

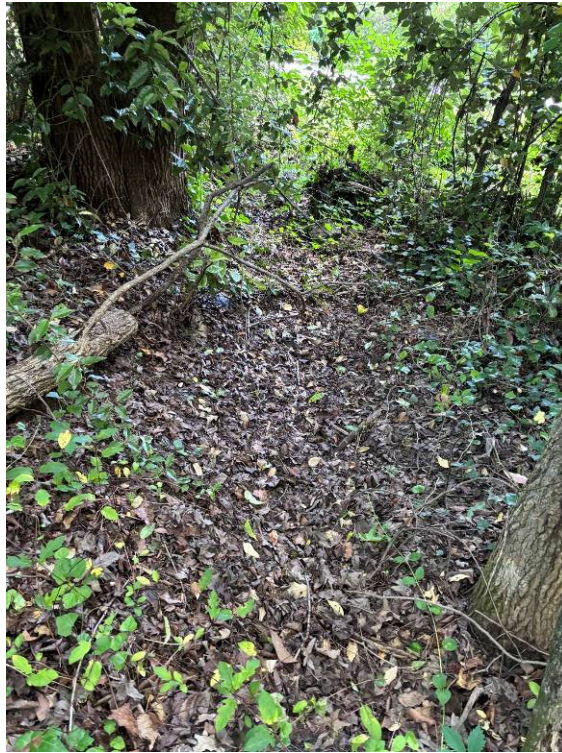
Photo 13: Accumulation of debris and sediment at the end of the shallow swale preventing positive flow into roadside ditch.

Remove the debris accumulation in the confluence between the ditch from the woods and the roadside ditch. This will enable the wooded area to properly drain into the existing ditch downstream of the woods and prevent a backup of water. This work can be done by hand and should be a regularly scheduled maintenance item.

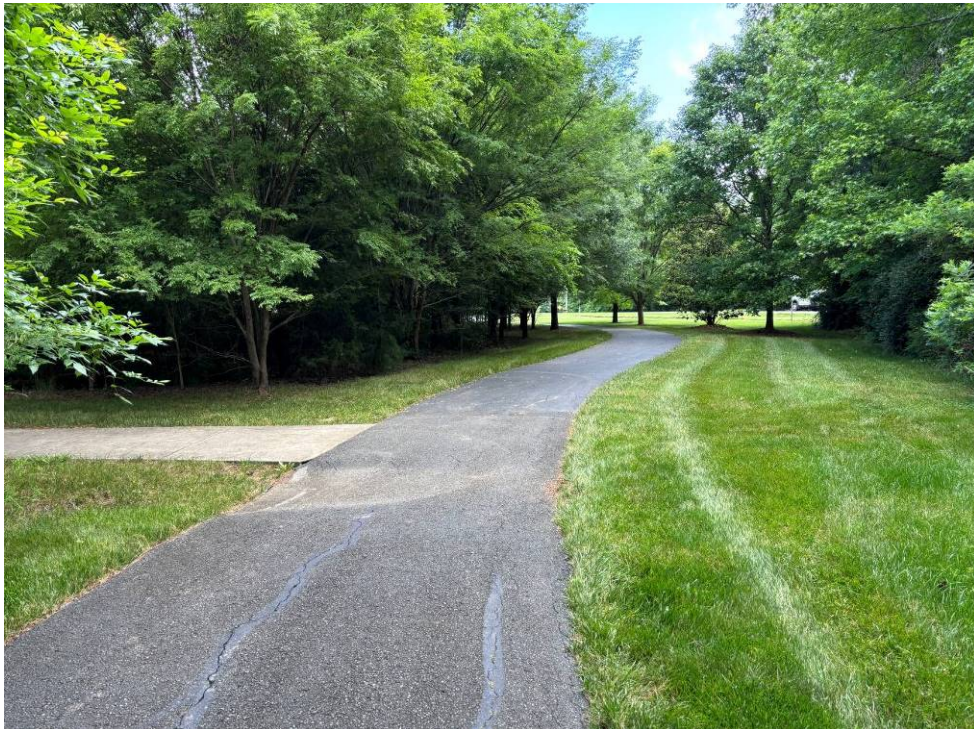
Photo 14: Connecting trail to Arborvitae Court. Note discoloration on the trail where water ponds.

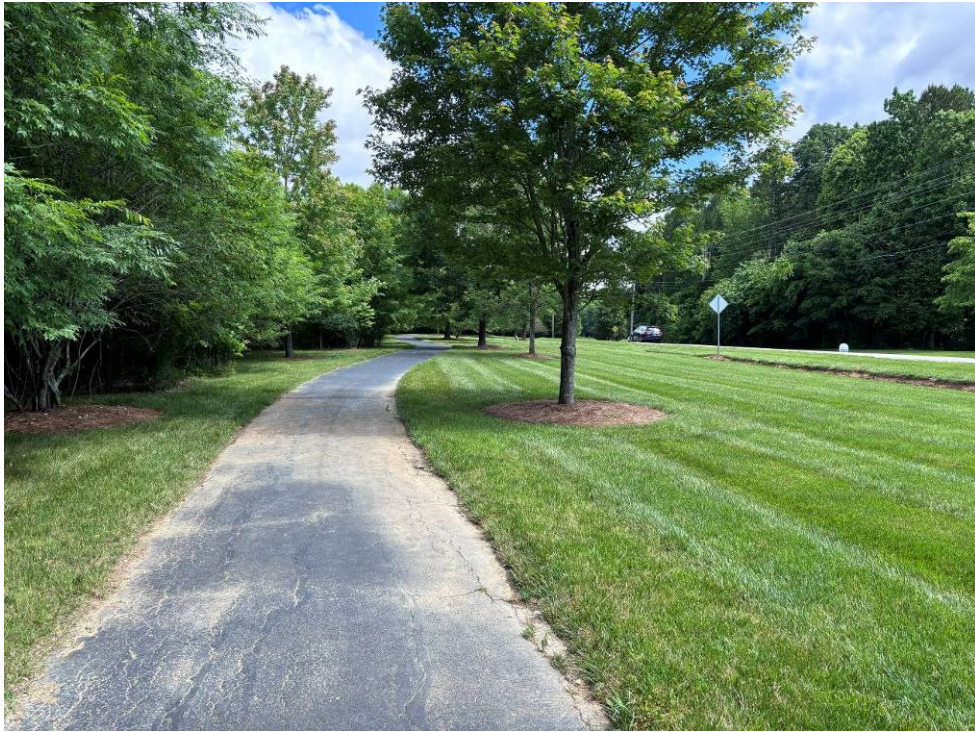
Photo 15: Northbound trail. Note discoloration on the trail where water ponds.

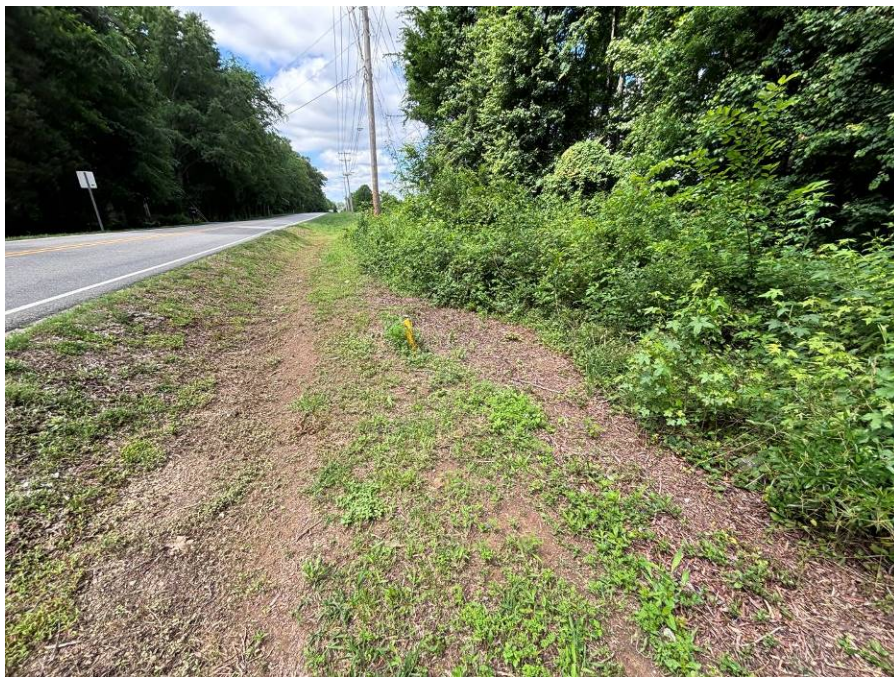
Photo 22: Existing ditch along wood line, note debris accumulation along the brush indicating runoff flowing into the woods. Culvert under the road is near the utility pole in the background.

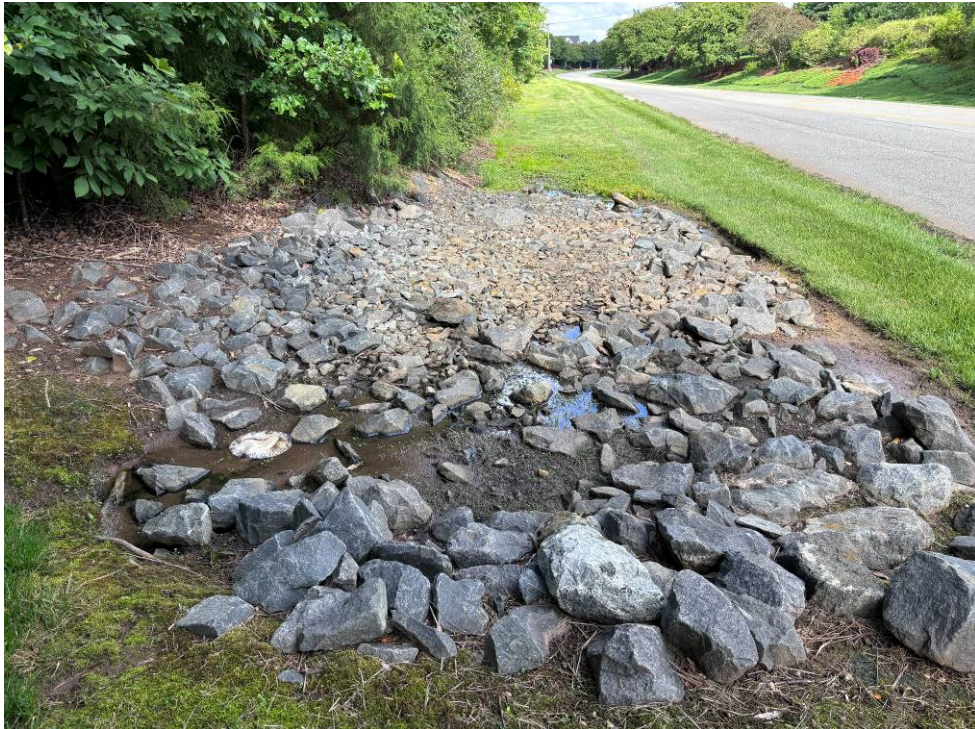
Photo 5: Riprap at outfall of storm drain system (inlets along Autumn Blossom Lane) Outfall pipe is partially buried.

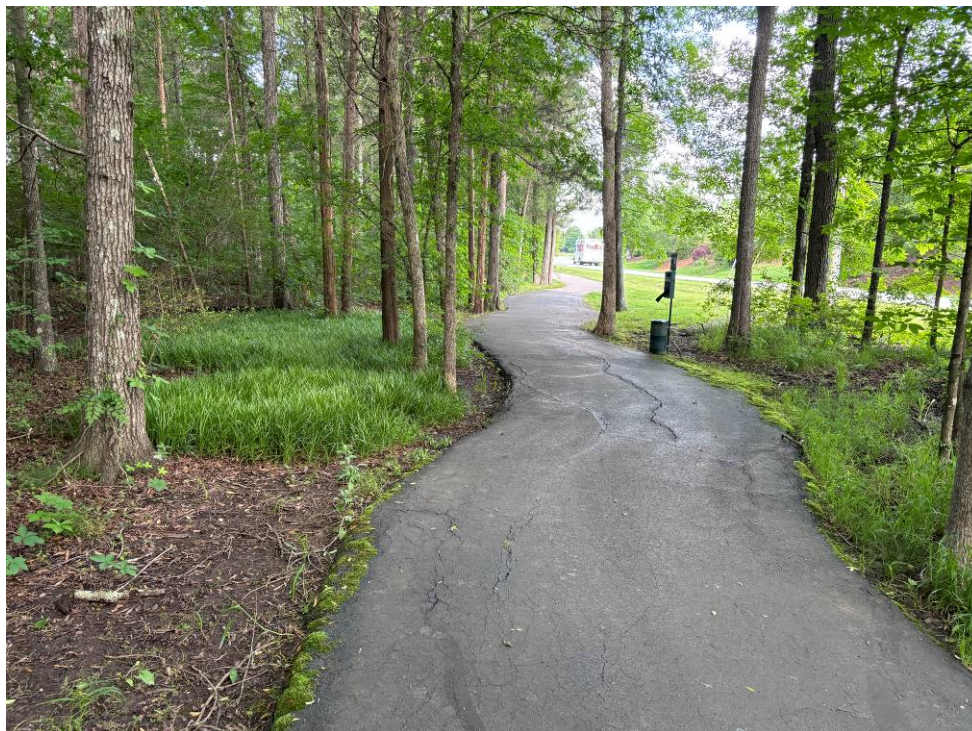
Photo 7: Trail heading west. Sediment and wet soils on either side of trail.

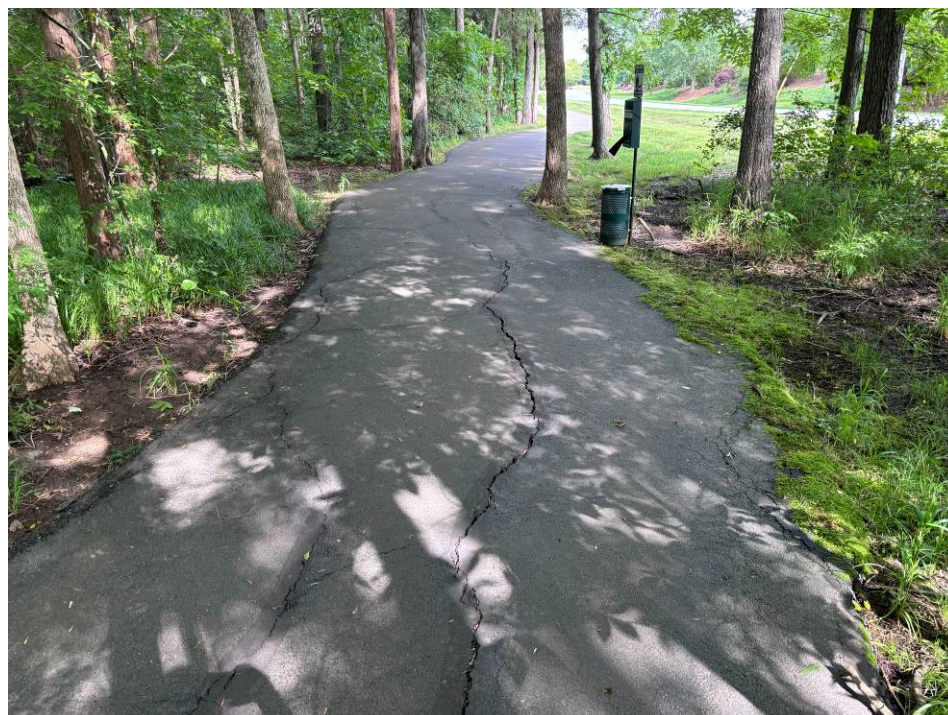
Photo 8: Trail heading west. Sediment and wet soils on either side of trail

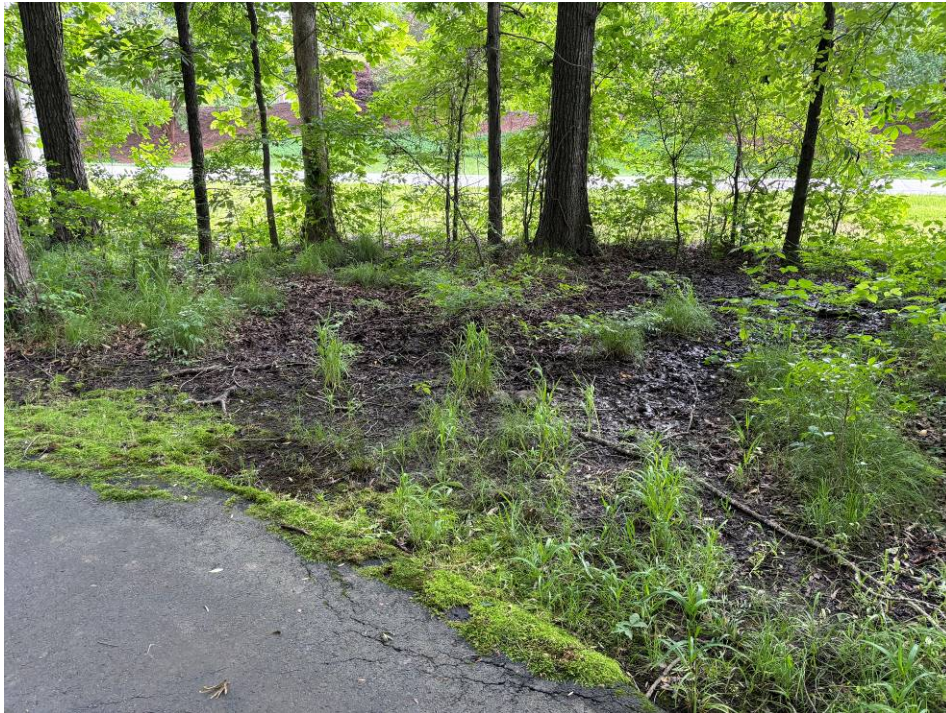
Photo 9: Trail heading west. Sediment and wet soils between the trail and road.

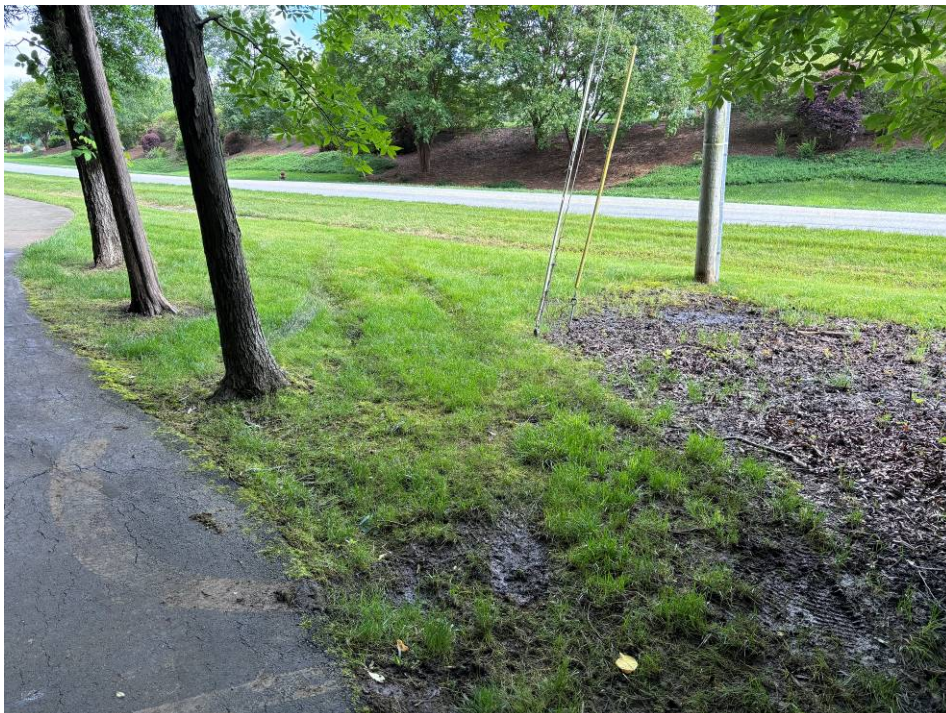
Photo 10: Trail heading west. Sediment and wet soils between the trail and road.

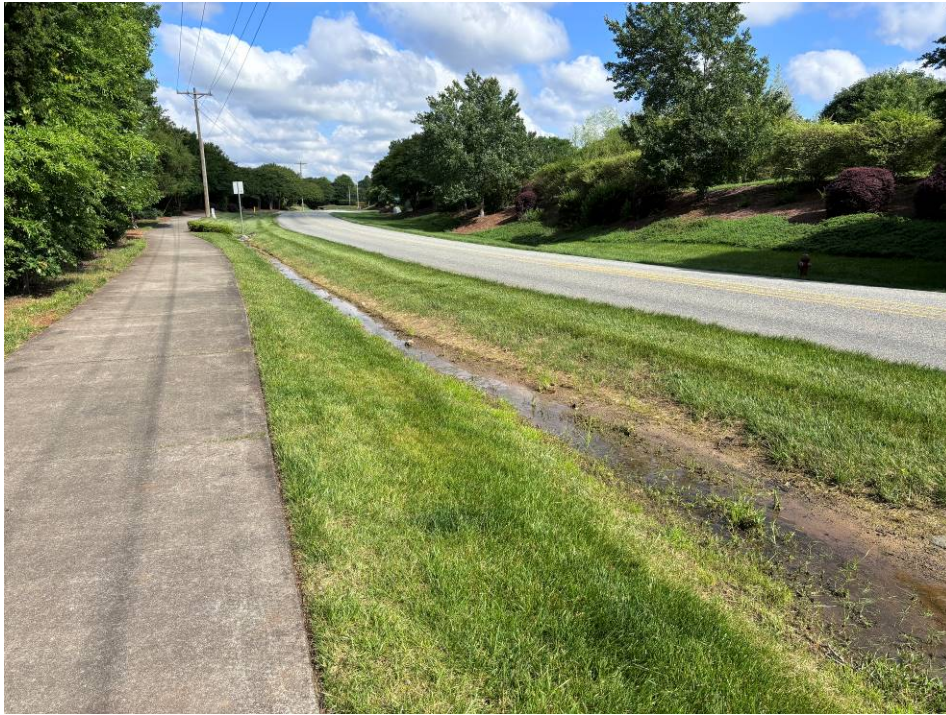
Photo 11: Shallow wet roadside ditch west of the woods.

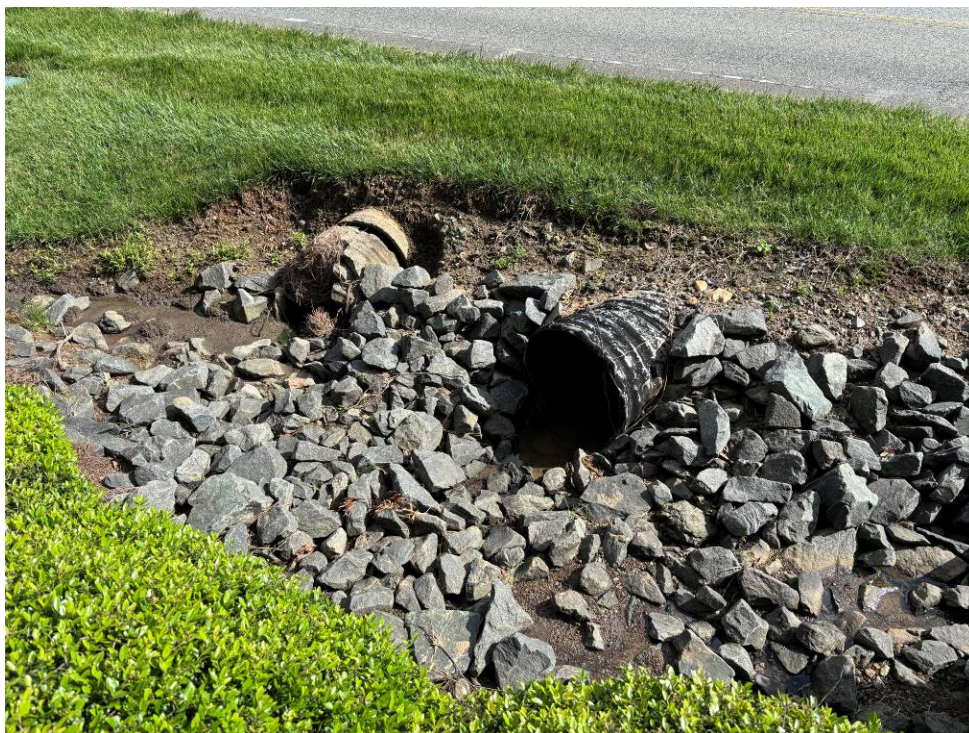
Photo 14: Upstream end of the culverts under Joe Kerr Road. Note the RCP on the left is broken and clogged.

This option should be implemented in conjunction with Option 1. Clean and repair of the culverts under the trail and Joe Kerr Road is recommended to improve functionality and capacity of the pipes. With the increased efficiency and conveyance capacity of the upgraded ditches, the culverts under Joe Kerr Road could result in a back up of flow and flooding on the trail and the road. Based on preliminary sizing computations, the CMP culvert alone is not adequately sized to convey the 25-year storm peak discharge of 25.86 cfs however with the combined capacity of a clean and fully functioning RCP culvert, the 25-yr event may be safely conveyed under the roadway.

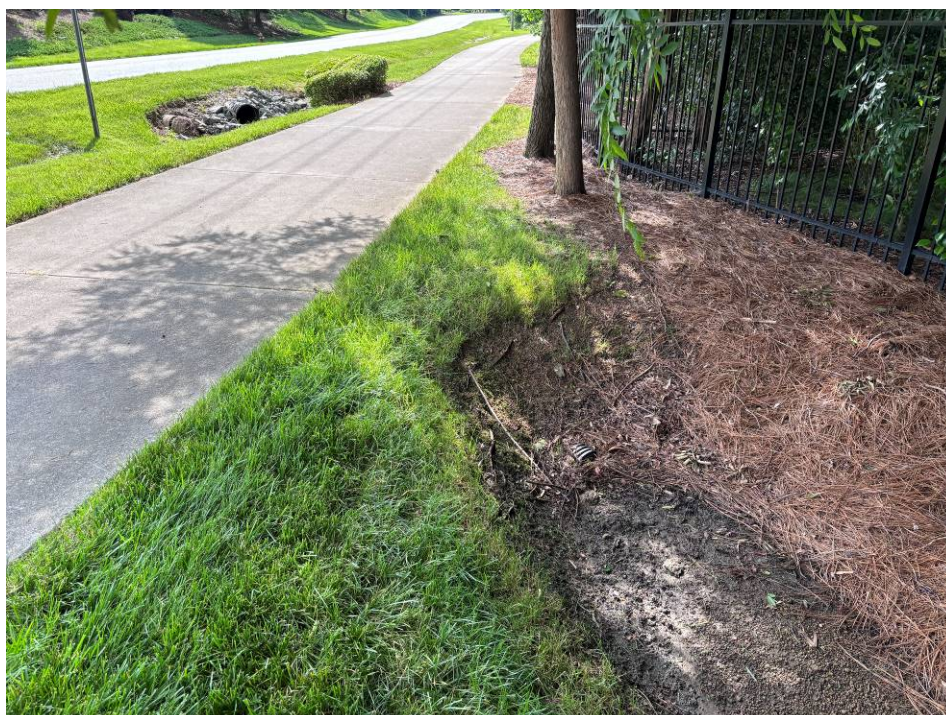
Photo 16: CMP pipe from adjacent residential area to the culverts under Joe Kerr Road. Pipe is almost completely buried.
