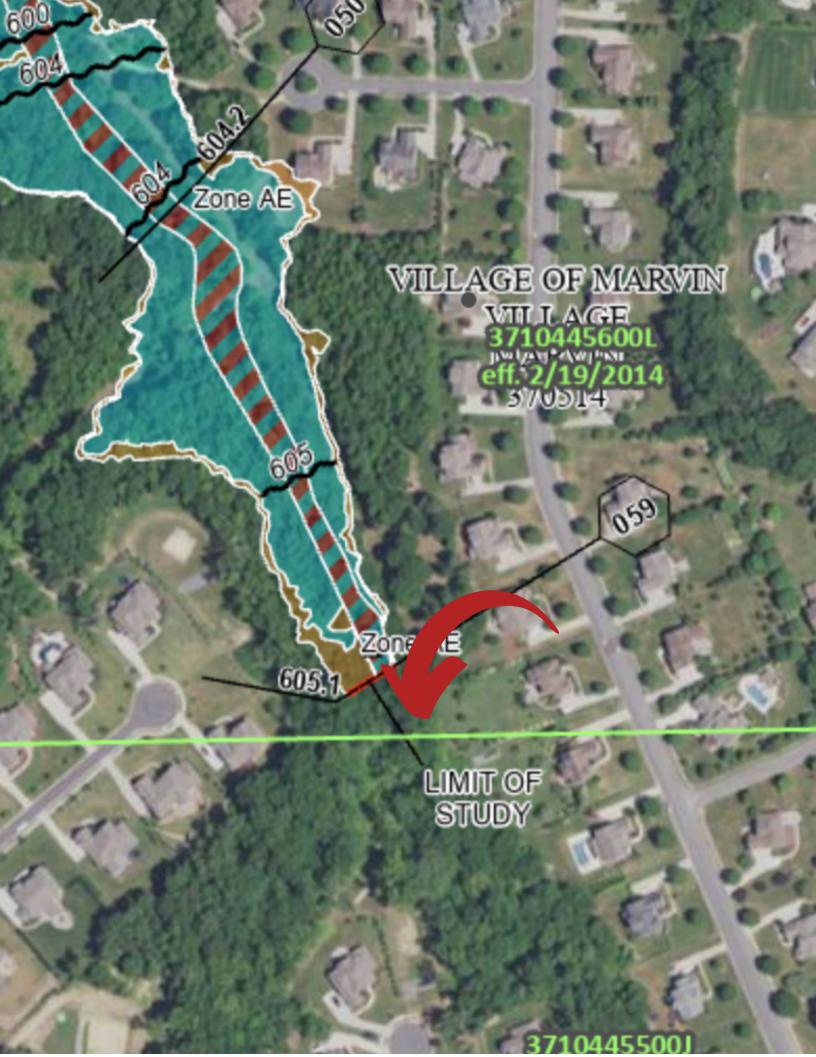
The Village of Marvin is proposing a reroute for the Connector Trail to avoid the mapped floodplain and cross the creek at this approximate location. However, the creek itself, the natural riparian buffer, a sanitary sewer easement, and a private fence are all present in this photo. In addition to assessing existing sidewalk connectivity, it is vital to assess potential encroachment of private property lines, floodplain boundaries, sewer easement markings, and riparian buffers throughout the proposed rerouted trail. The map that was presented at the recent Village Council meeting lacked clarity on the aforementioned details.

While the floodplain study may not extend this far, the creek widens significantly at this point, suggesting it might function as a floodway. To avoid potential issues, it's crucial to confirm if an engineering certification is necessary for construction in this area. Consulting with NFIP Auditor Terry Foxx regarding this specific location and the potential floodway designation would be very beneficial.
